Analysis of VTOL MAV Use During Rescue and Recovery Operations Following
Hurricane Katrina

A thesis submitted in partial fulfillment
of the requirements for the degree of
Masters of Science in Computer Science
Department of Computer Science and Engineering
College of Engineering
University of South Florida

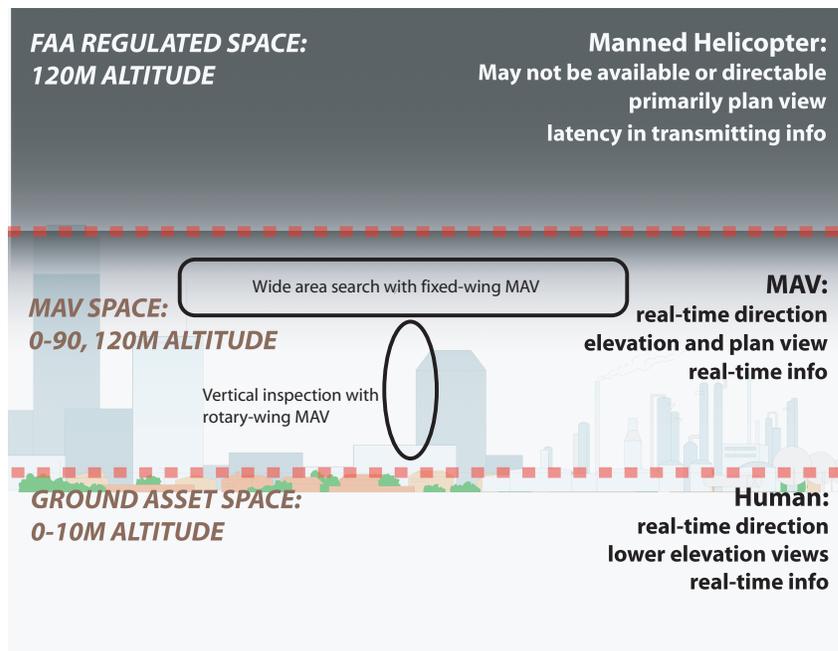
Figure 1: Vertical profile of an urban structural inspection task overlaid with asset operation zones. Rotary-wing MAVs provide increased capabilities over ground-based assets, and provide these capabilities at a lower cost and with a shorter sensor-analyst path than manned rotary-wing aircraft.

In the past, structural inspection tasks have typically been accomplished by ground assets or manned aircraft. While each of these methods have their advantages, they also have an overlapping set of limitations. As shown in Figure 1, this missing segment is the space below FAA regulated airspace, but above what can be achieved with ground-based resources. This space is perfectly suited for MAV operations. In particular, rotary-wing MAVs operating in this space can provide all of the data types presented in the initial task analysis.

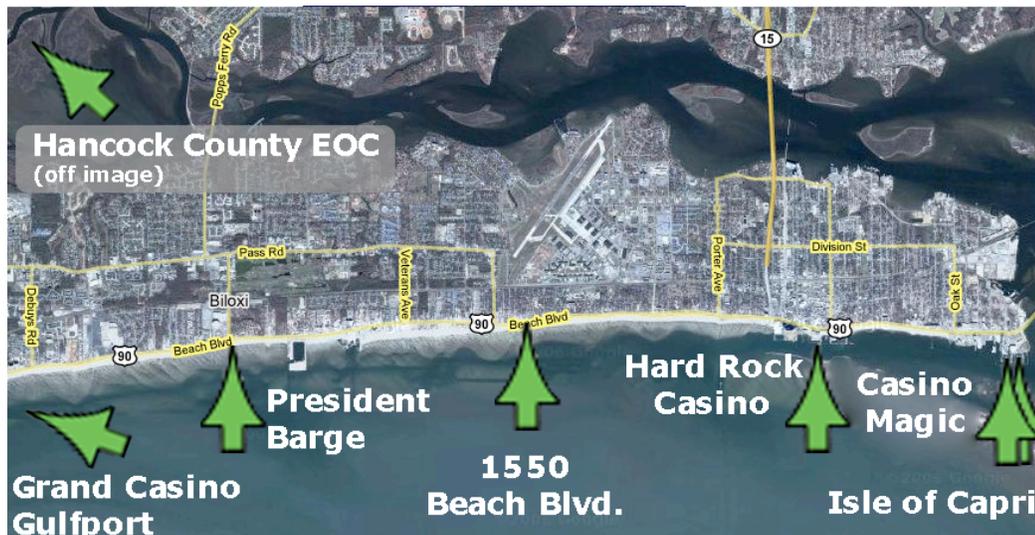
Figure 2: Map of Biloxi, MS showing locations of structures surveyed by the CRASAR team between November 26th - December 5th, 2005. Map © Google, 2006.

From November 26th - December 5th, 2005 a team of researchers from CRASAR deployed to Hancock County, MS to conduct structural surveys of multi-story commercial structures in Biloxi and Gulfport, MS. During this time the team conducted 12 different missions at 7 different sites with a total of 32 flights during all missions. Figure 2 shows the locations of these flights and Table 1 provides the dates and locations of the different missions.

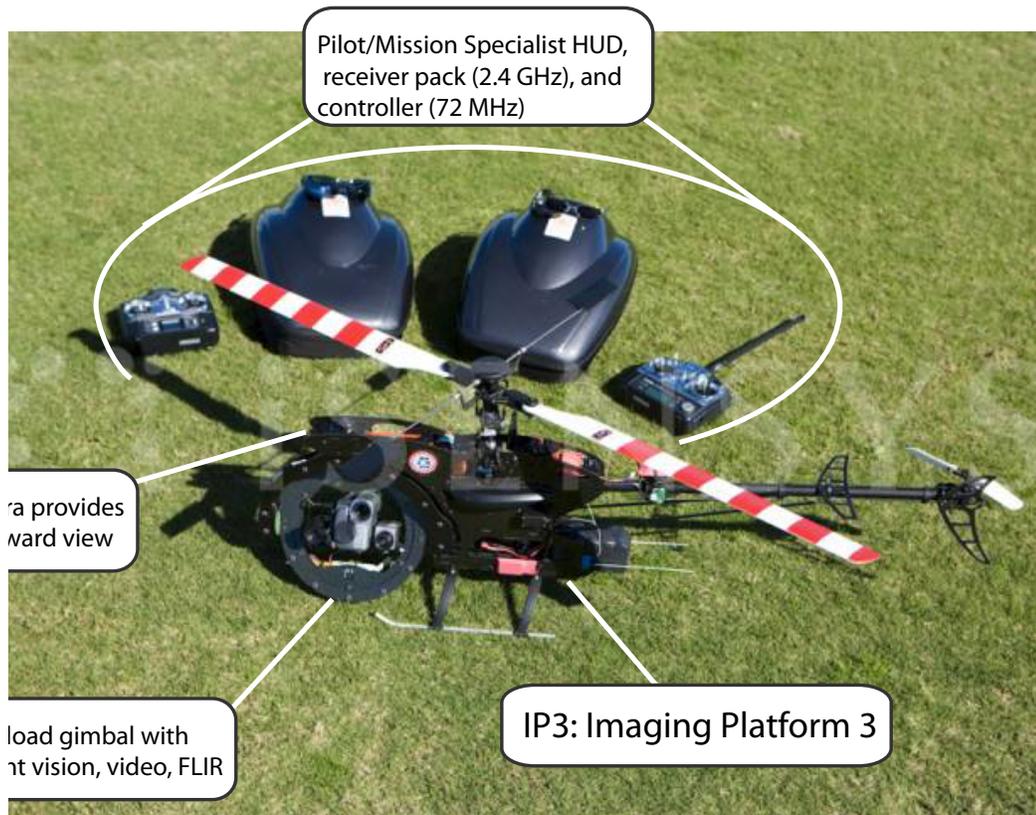
Figure 3: iSensys IP3 MAV plus Pilot and Mission Specialist operational equipment. Image © iSensys, Inc.

In addition to the IP3, both the pilot and the mission specialist were outfitted with 72 MHz wireless controllers, 2.4 GHz wireless video receivers, Heads-Up Displays (HUDs), and video cameras to record all received data. Figure 3 illustrates all of this equipment.

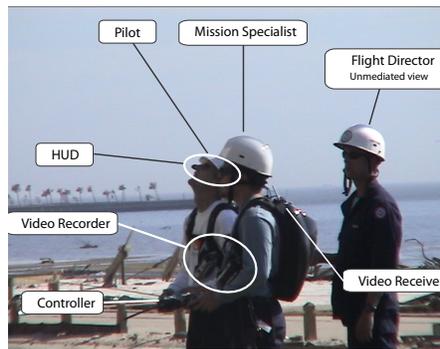
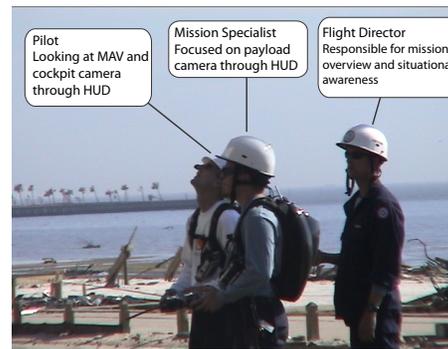
(a) Flight Team with equipment

(b) Flight Team with mission responsibilities noted

Figure 4: Flight team with equipment noted and with team member responsibilities.

Figure 4 shows the IP3 equipment in use on the flight team, as well as the team organization and responsibilities during a mission.

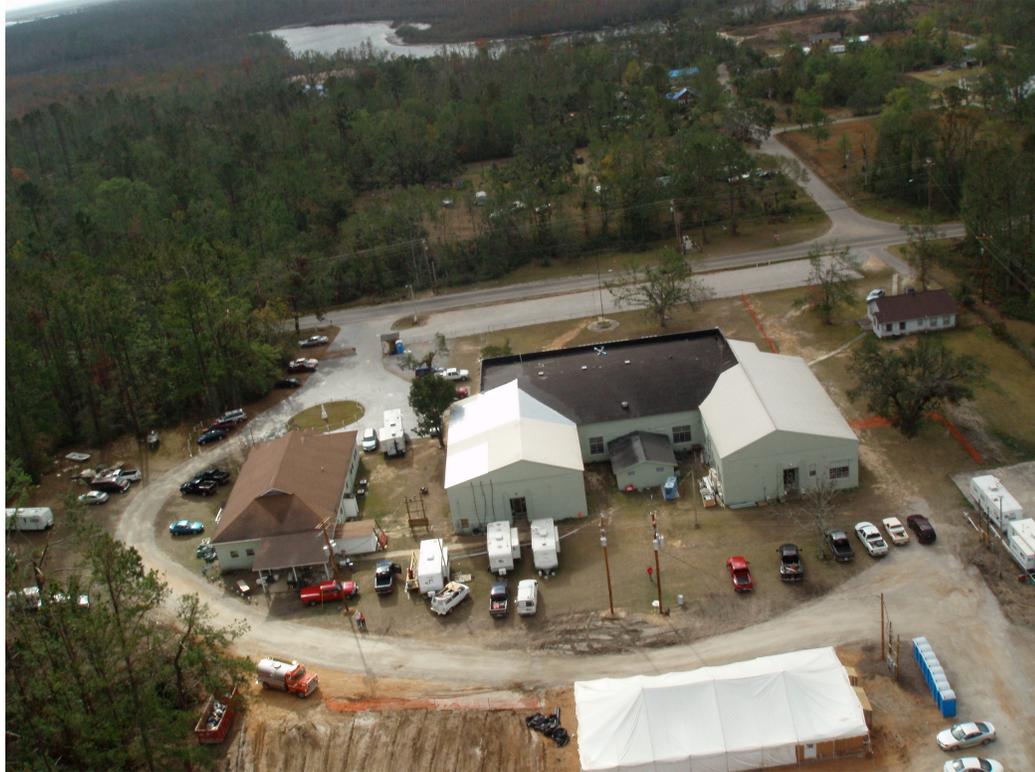
Figure 5: Picture of the EOC in Hancock County, MS. This was taken during our third test flight at the site.

Even though it was not one of the multi-story commercial sites we were there to photograph, we flew the most number of flights at the Hancock County Emergency Operations Center (EOC). And while it was not a research target, these flights were just as important, as they gave us an opportunity to evaluate and test our teamwork processes, optics and video systems, and our control methods. Figure 5 shows an overview of the EOC taken during one of our test flights.

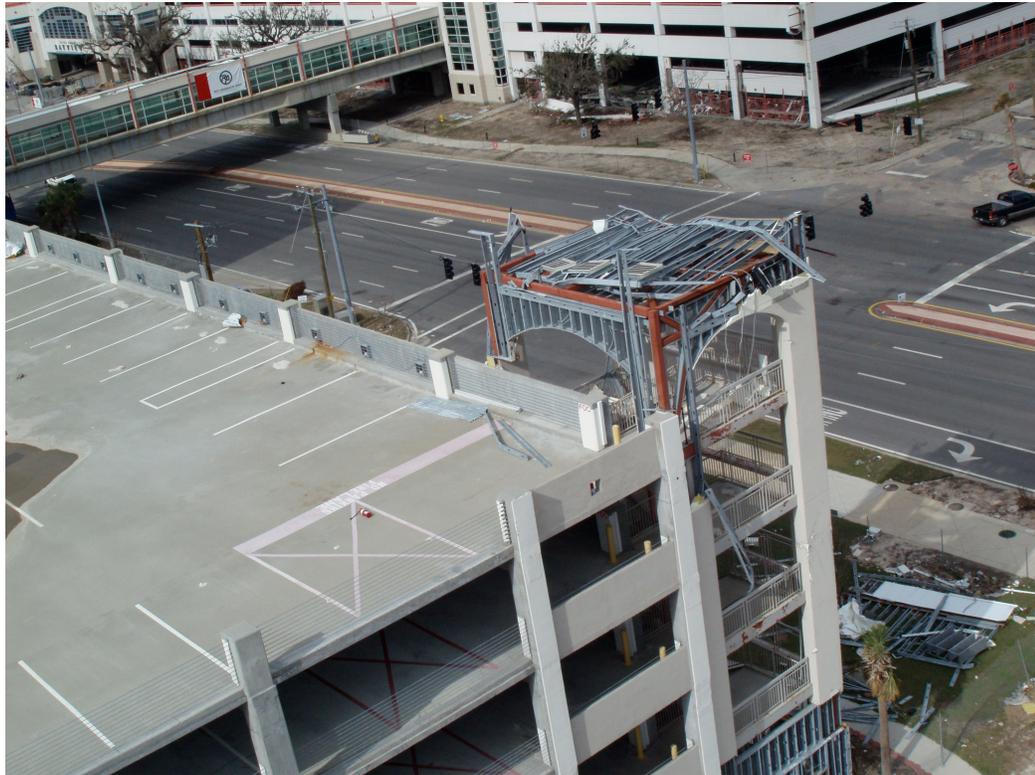
Figure 6: Northeast corner of the parking garage adjoining Casino Magic. Part of a set of images we used to evaluate the integrity of the upper deck.

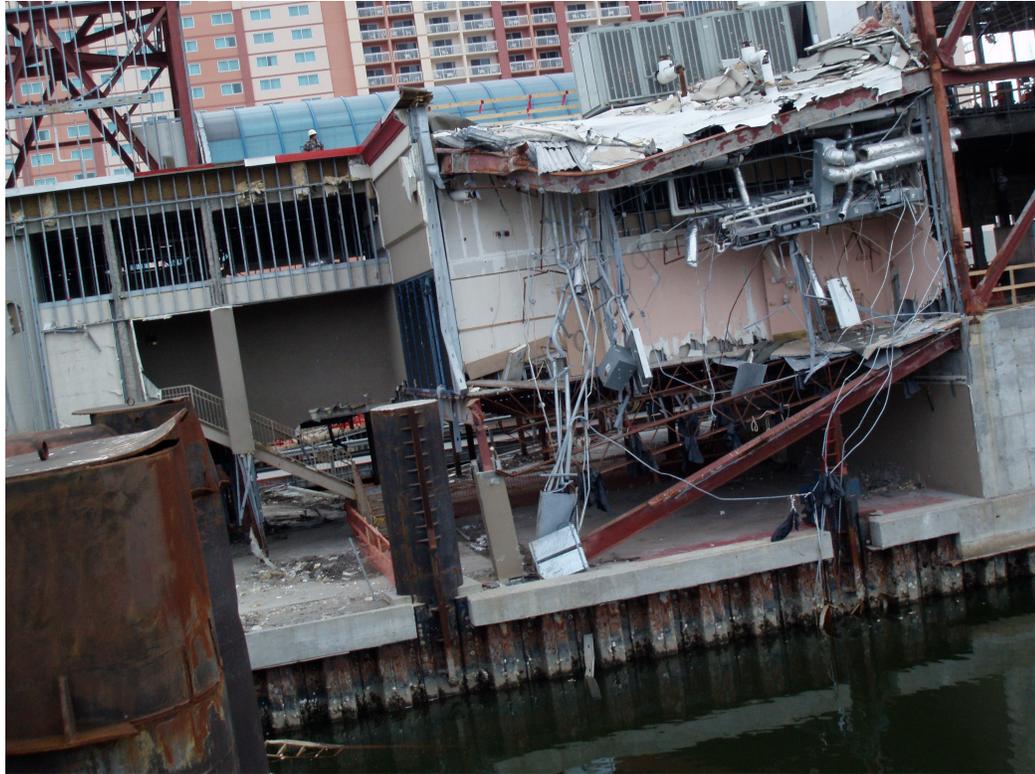
Figure 7: Picture of the barge pilings at Casino Magic, and the damage to the hotel caused by the free-floating barge once broken loose by the storm surge.

During the second mission at Casino Magic, we turned our attention to the barge mooring area. As with several barges in the area, the storm surge caused the Casino Magic barge to break its moorings and float free. Once free, the wave action on top of the storm surge turned the barge into a battering ram and caused severe damage to adjacent structures. In Figure 7 both the pilings the barge was originally moored to, as well as where it rammed the structural beams of the adjoining hotel are clearly visible. The pilings shown here are one clear example of the flight path obstacles that can be encountered during these operations (see Section 7.2 for more details).

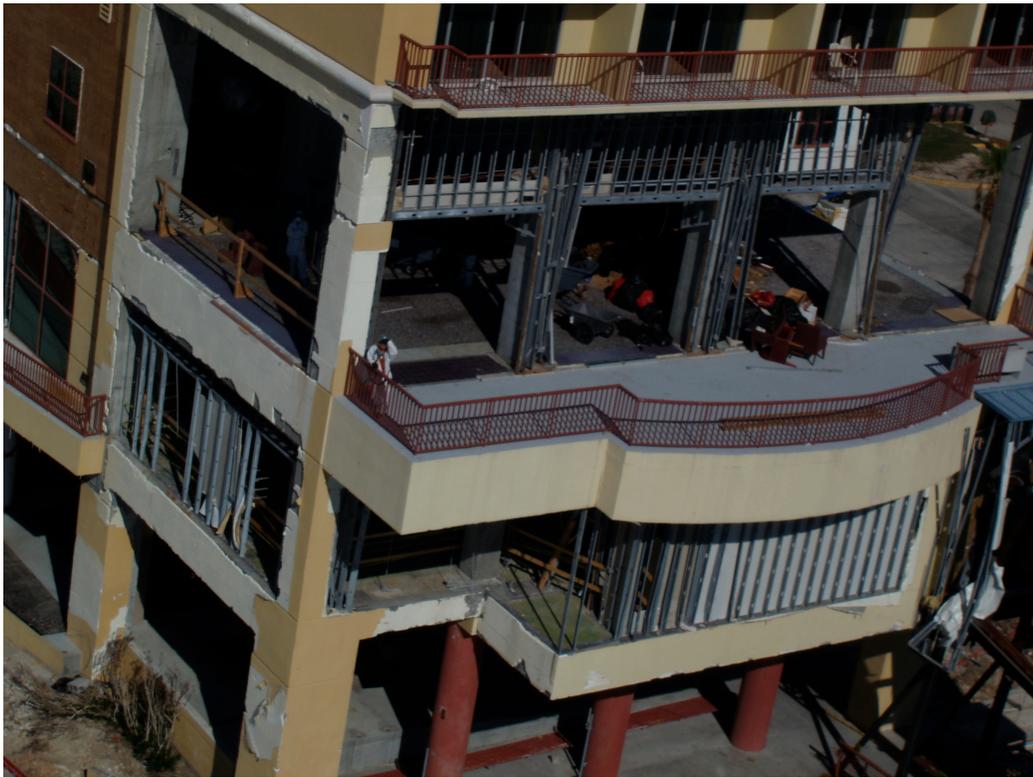
Figure 8: Detail of partially repaired damage to the south facing side of the Grand Casino, which absorbed the brunt of the wind and storm surge damage.

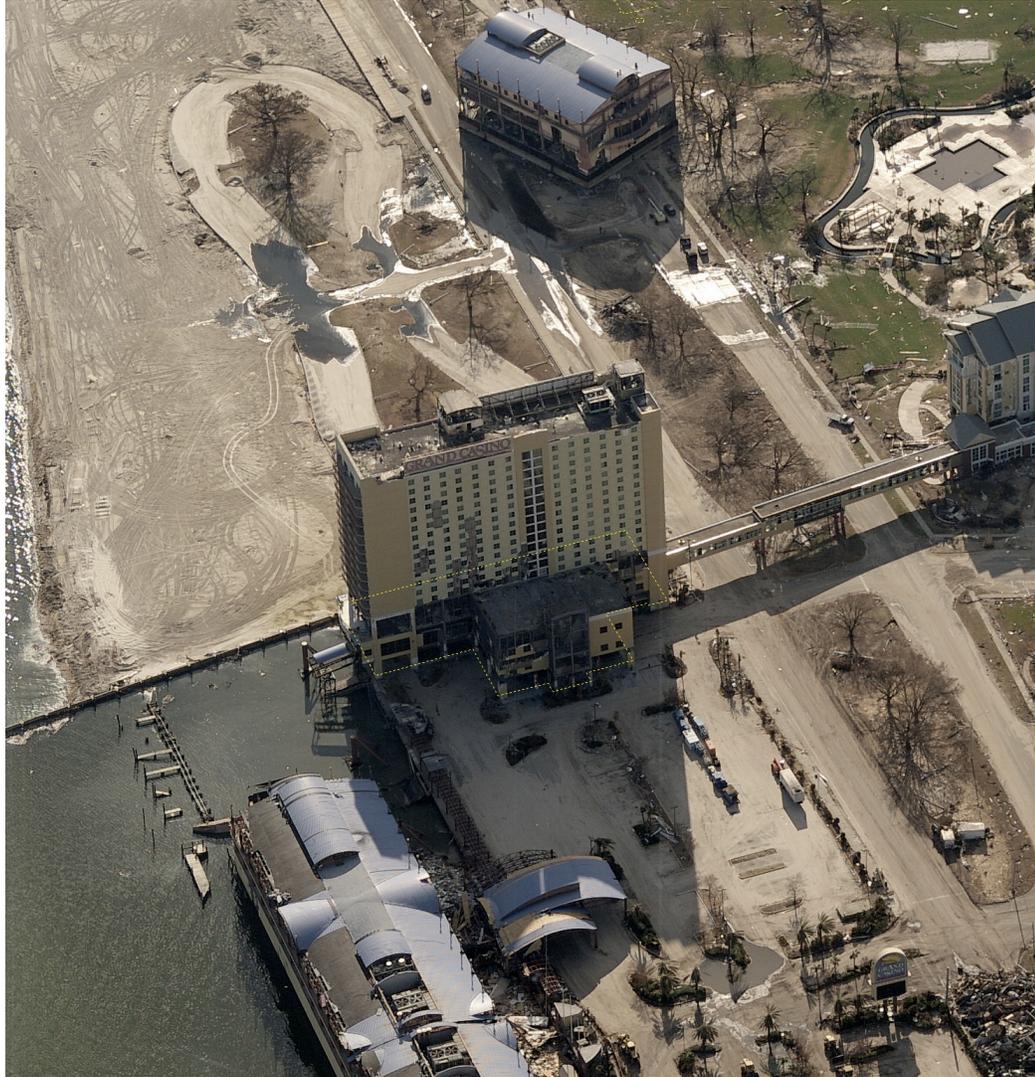
Figure 9: Overhead pictometry of the Gulfport Grand Casino. The blue-roofed barge which is missing from in front of the Grand can be seen near the top of the frame. This was an unfortunately common occurrence up and down the beach. Image is © Hancock County EOC, 2005 and is used with permission.

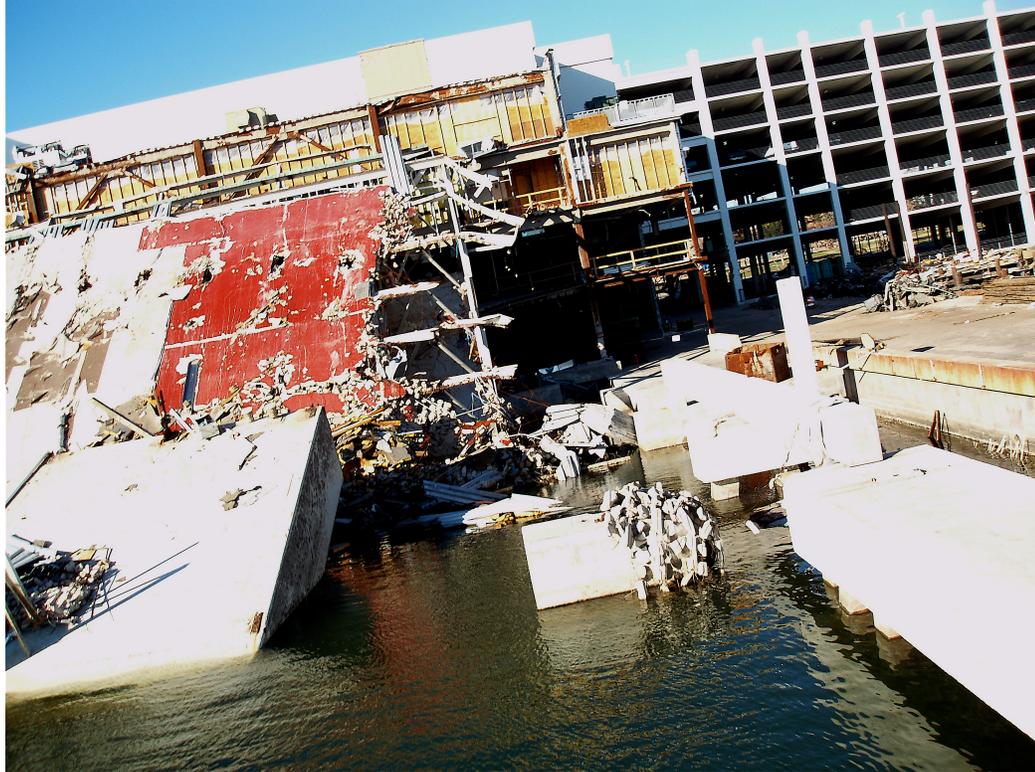
Figure 10: Picture of the eastern half of the two stacked barges leaning against the land-side building at the Hard Rock Casino. The white deck on the left is the first barge (with all superstructure removed by the storm), and the red deck is the 2nd floor of the second barge. The rusted steel frame members are the south-facing wall of the building section.

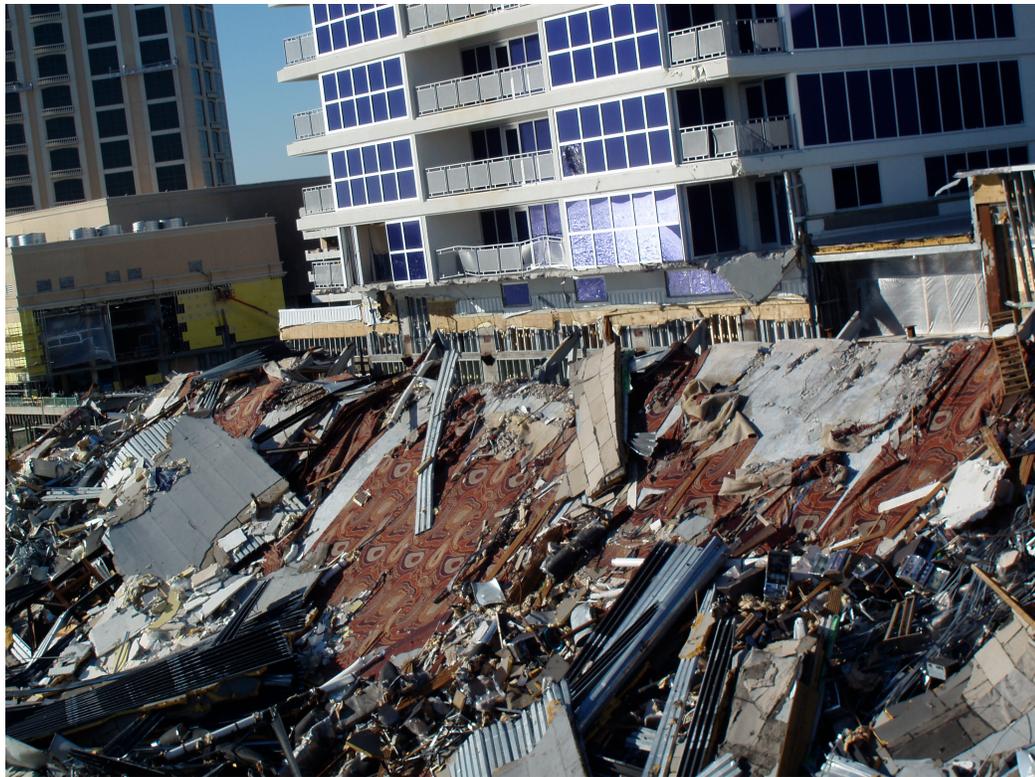
Figure 11: Detailed picture of damage to a guest room balcony. The second barge can be identified by the red patterned carpet in the lower left. This picture is approximately 50 m west of the image shown in Figure 10.

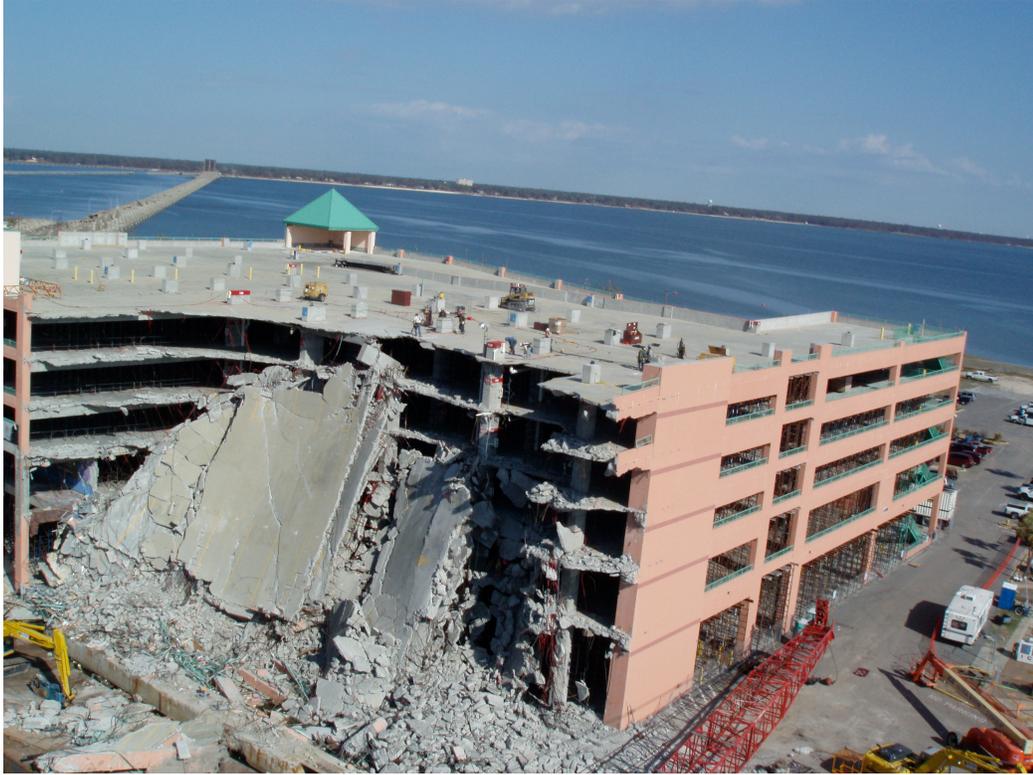
Figure 12: Collapsed portion of the Isle of Capri parking garage damaged by a loose barge. The I-90 bridge (Figure 14) is visible on the left side of the frame.

ultimately causing the collapse of approximately one quarter of the parking garage. Figure 12 shows this multi-story hanging collapse on the parking garage.

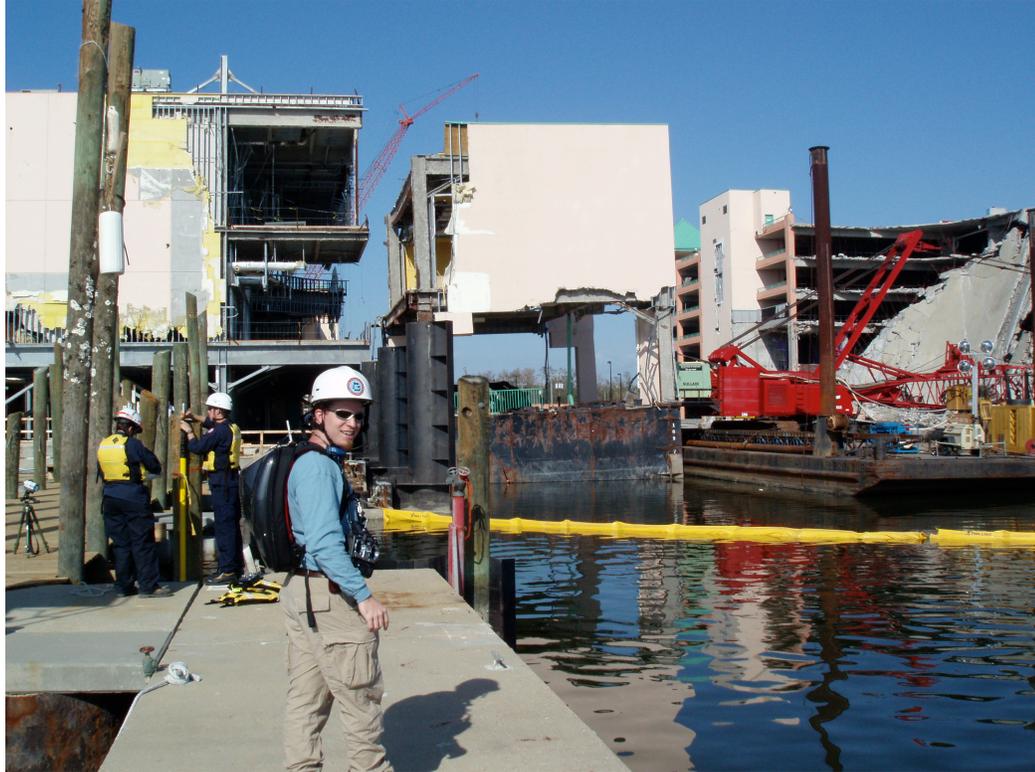
Figure 13: Yacht club dock used to launch the IP3 to survey damage at the Isle of Capri. The launch hazard presented by the support poles is clearly evident in this shot.

In order to survey this damage to the parking garage we were required to launch from the yacht club dock behind the original mooring position. As detailed in Section 7.2, the pilings on this dock provided a very clear case for the need for obstacle avoidance technologies on a semi-autonomous MAV platform. Figure 13 below shows the dock with the launching location, as well as the dock's orientation to the parking garage to be surveyed.

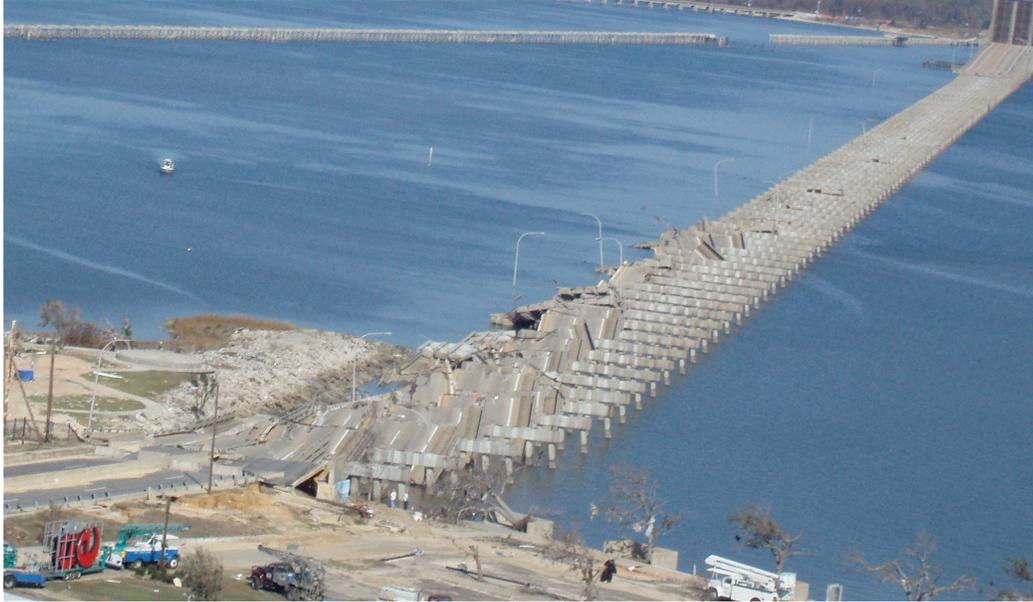
Figure 14: I-90 bridge heading east from Biloxi. As can be seen across the entire span, the combined storm surge and wave action lifted and then collapsed all of the deck segments of the bridge. This image was taken from the opposite side of the Capri parking garage and illustrates a valuable use case for MAVs conducting tactical reconnaissance for SAR units during the response phase.

a very clear shot of the damage to the decking of the I-90 bridge eastbound out of Biloxi (Figure 12 shows the bridge in the background behind the garage). From the ground, we had no way to determine what condition the bridge was in, and were we operating as responders during the hours and days following Katrina we would have needed to make our way to the bridge, determine that it was impassible, and backtrack and come up with an alternate route. Even though the bridge was a short 2 km away from the dock, during the Katrina response progressing that far sometimes took the FEMA SAR teams hours as they picked their way through the trash and debris the receding storm surge had left in most of the streets and roads [40].

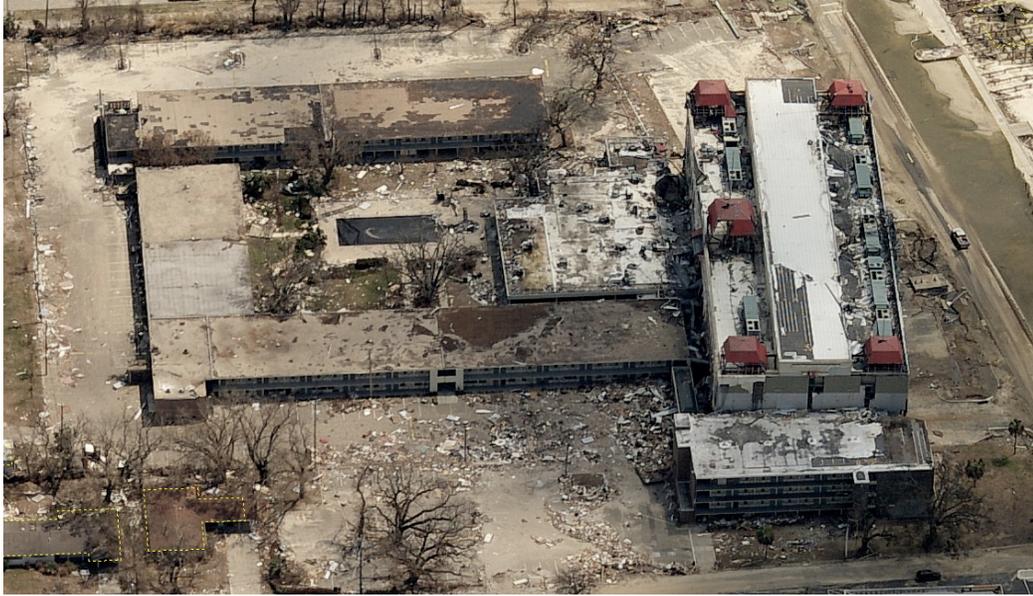
Figure 15: The President Casino barge where it came to rest approximately 1 km down the beach from its original mooring. The barge is the structure on the right of the frame topped by the red towers. The remaining buildings are part of Motel 6. Image is © Hancock County EOC, 2005 and is used with permission.

While many of the casino barges broke loose and landed elsewhere, the President Casino barge covered the most distance during the storm, ending up 1 km west and 100 m inland of its starting location. What finally stopped the barge from drifting any further was its collision with the roof of the Motel 6. As Figure 15 shows, once the water receded the barge was left high and dry next to the motel. During our flights around the President Casino barge we concentrated primarily on the three closest sides of the barge and the interface between the barge and the motel (seen in greater detail in Figure 21).

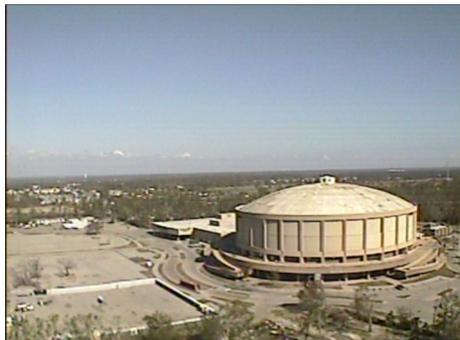
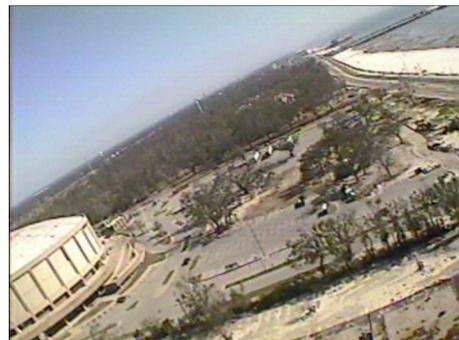
(a) Nominal pilot cam view

(b) Pilot cam view during a hard-banked nose dive caused by a radio glitch.

Figure 16: Images comparing nominal and aberrant pilot cam images from President Casino barge survey. At the time of the glitch the IP3 was at the edge of the pilot's perceptual range. As noted by the pilot during the mission debrief, without the pilot cam providing a horizon line, the glitch would have caused the loss of the craft.

from the parking lot at the bottom of the frame, thus in order to get a good view of the entire length of the barge we had to fly at a somewhat extended range, limiting the pilot's perspective and perception of the helicopter. At one point, a radio glitch to the cyclic threw the helicopter out of a stable hover and into a left roll. As noted by the pilot immediately following, had we not had the pilot cam at that point, it would have been impossible to recover the helicopter. Figure 16 shows a comparison between the nominal view from the pilot cam and the image presented during the radio glitch.

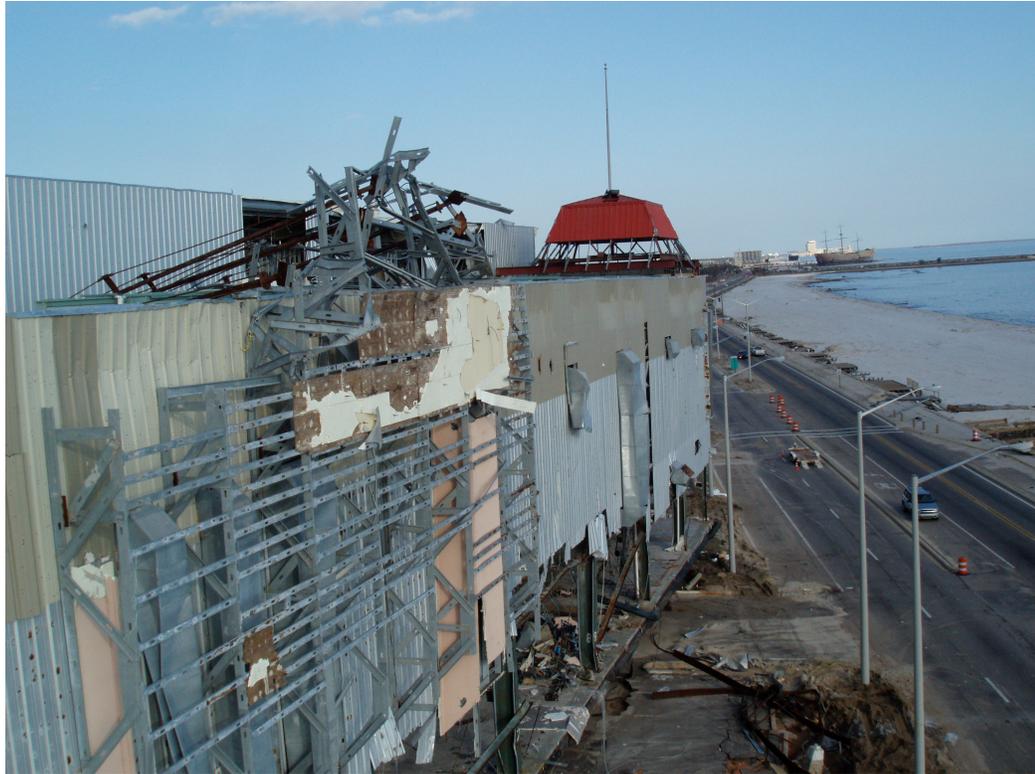
Figure 17: South face of the President Casino barge showing exposed and mangled metal superstructure, steel beam construction, and hanging wires (primarily on first floor) which caused a high level of radio interference while flying near the barge. As with much field-work, and particularly emergency response operations, conditions are often very different from controlled testing, and most often for the worse.

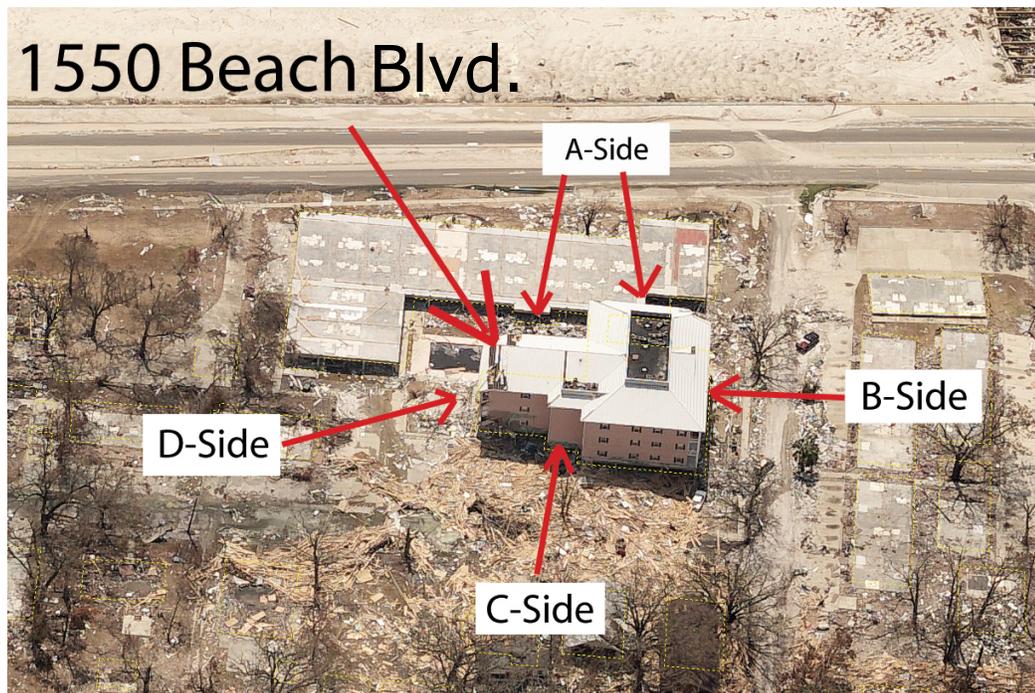
Figure 18: Pictometry of 1550 Beach Blvd. Shown the concrete foundation of the destroyed building (near the top), the remaining building in the middle, and the accumulated flotsam and debris just below it. Image is looking south, with the beach visible along the very top of the frame. Image is © Hancock County EOC, 2005 and is used with permission.

The final location inspected was 1550 Beach Blvd., a two-building 4-story residential block. This was the only residential building inspected and as such, the only wood-frame (as opposed to steel frame) structure we inspected. The two buildings at the site were stacked in a roughly north-south orientation which consequently caused the southern building to act as a breakwater and absorb the majority of the wave action directed at the site. When we arrived, all that remained of the southern site was the concrete foundation, and the northern building was listing approximately 15 degrees to the north, reflecting the storm surge and wave action pressure. Figure 18 shows the overhead pictometry of 1550

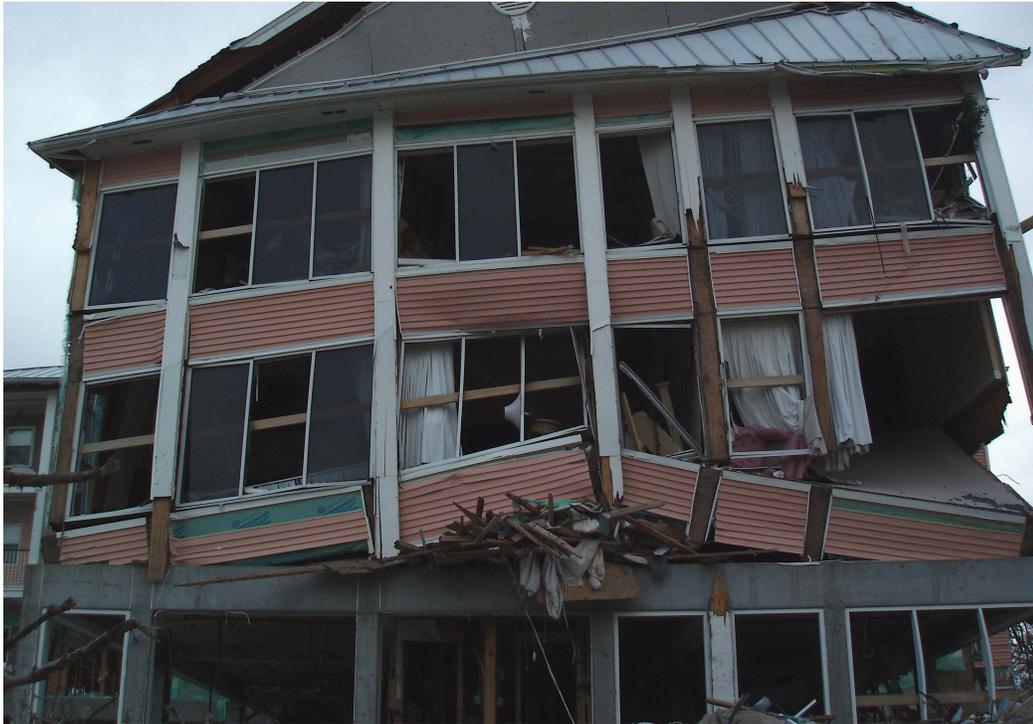
Figure 19: East face of 1550 Beach Blvd. showing collapsed second floor and damage to concrete/wood frame joint.

This debris accumulation, as well as the damage to all sides of the building, illustrated in Figure 19, made this location a prime demonstration of the necessity to conduct operations as multiple short flights, rather than one long flight per site. While it is possible for the pilot to perform limited relocations while flying, the large quantities of debris encountered by the FEMA USAR teams made transitioning around the building impossible while in flight [40]. The optimum operational tempo evolved to be to take off and inspect one face, land, relocate, and launch to inspect the new building face.

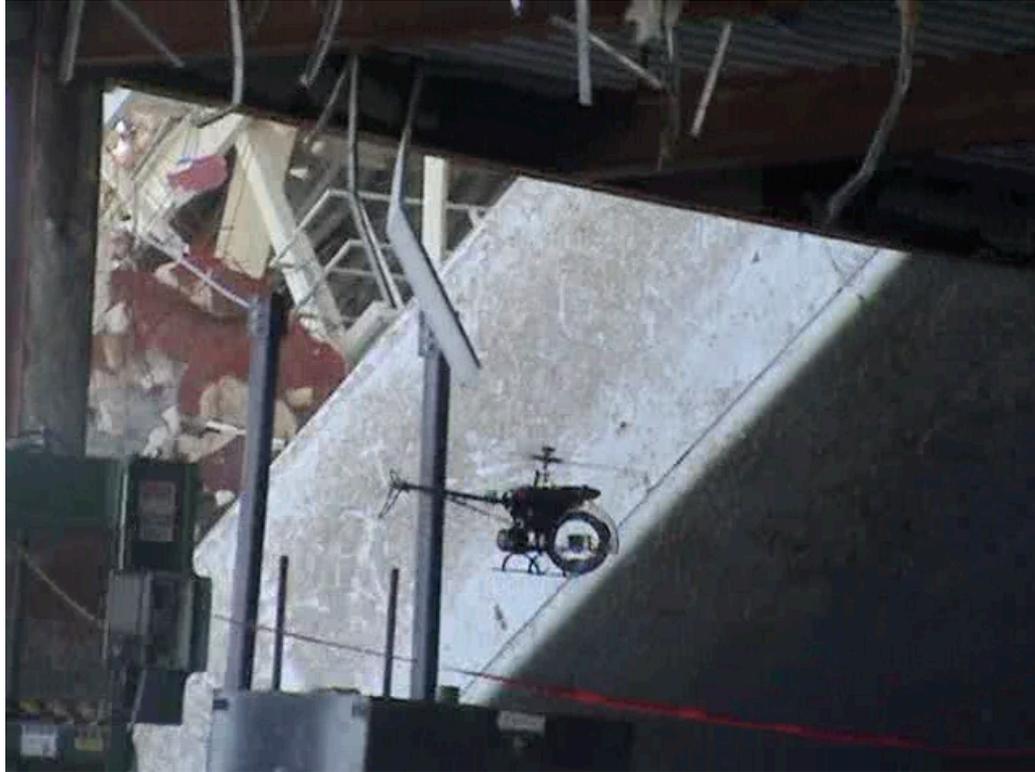
Figure 20 shows the most complex environment encountered with the IP3. In this image the IP3 was flying into a building to image a structural beam that had been compromised by repeated impacts from a barge that ended up resting on the structure. Above the IP3 is a solid steel ceiling as well as hanging wires and ceiling tile supports, below it are caution tape as well as a 2x4 barrier, and encroaching from multiple sides are a trash compactor and several structural steel beams. Additionally the hanging ceiling supports and the caution tape were light enough that they were moving in the wind and the rotorwash of the IP3. At other locations obstacles such as trees, flagpoles, electric and phone lines, building overhangs, and damaged building superstructure were all present in the flight path. While the vehicle will not need to come within 2-5 m of its intended target, any semi-autonomous MAV will need to be able to successfully detect and avoid all types of obstacles approaching from all angles.

Figure 20: The IP3 flying into a building to image concealed damage.

In addition to the barges and the associated area, while at the Hard Rock we also flew at a secondary location. As Figure 20 shows, we used the IP3 to penetrate the damaged section of the hotel and inspect structural members from underneath. As is evident, this provided some very difficult flying for the pilot and underscored the need for an omni-directional obstacle avoidance system as described in Section 7.2.

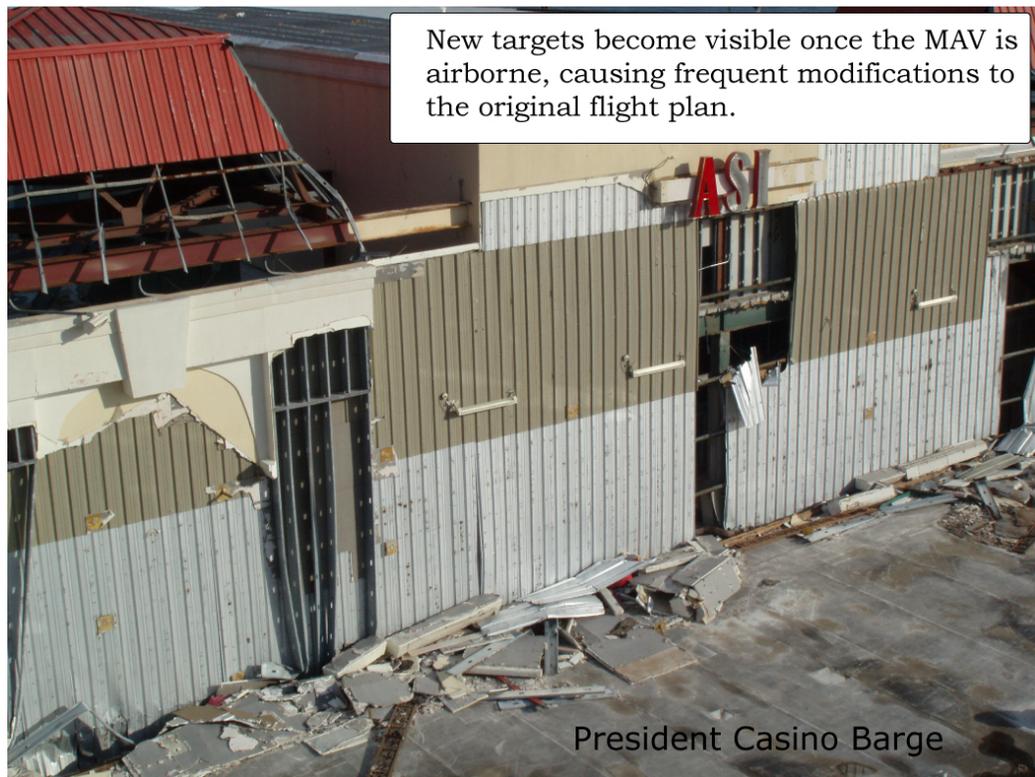
Figure 21: An example of why in-flight redirects were so common. The nature and extent of the damage could not be evaluated beforehand and had to be evaluated in-flight to determine what required further documentation and analysis.

be no damage at all, and until the helicopter can make an initial survey of this, it is not possible for the flight team to determine how much time needs to be spent surveying this damage. Figure 21 in Section 7.3 shows a detail shot of this joint.

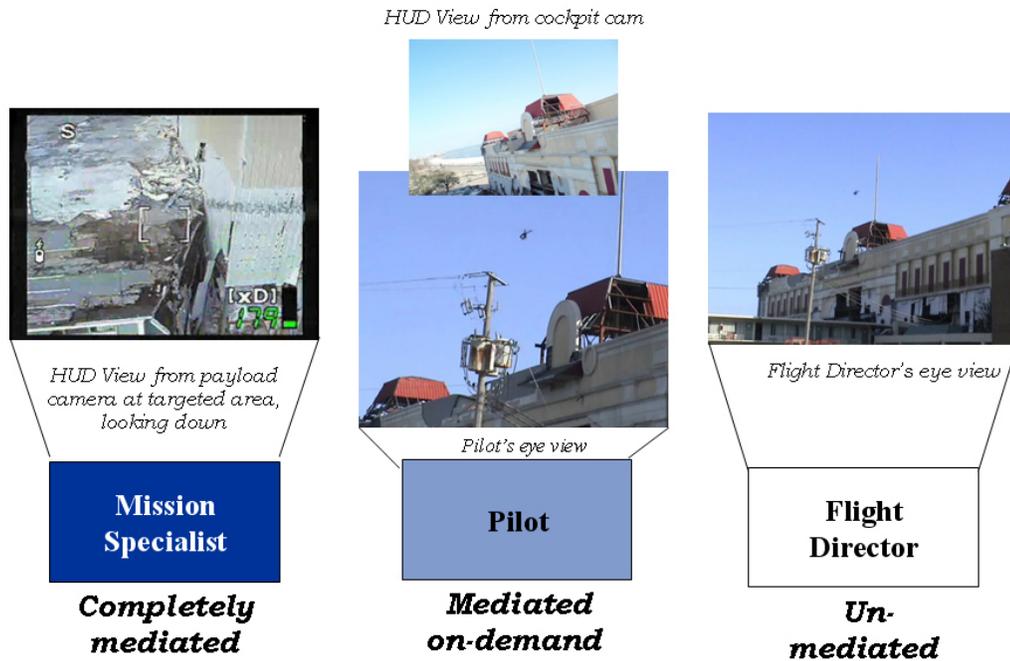
Figure 22: The three different views of the flight-team members. Each team member has a different focus and a different degree of computer mediation, making role combination difficult and undesirable.

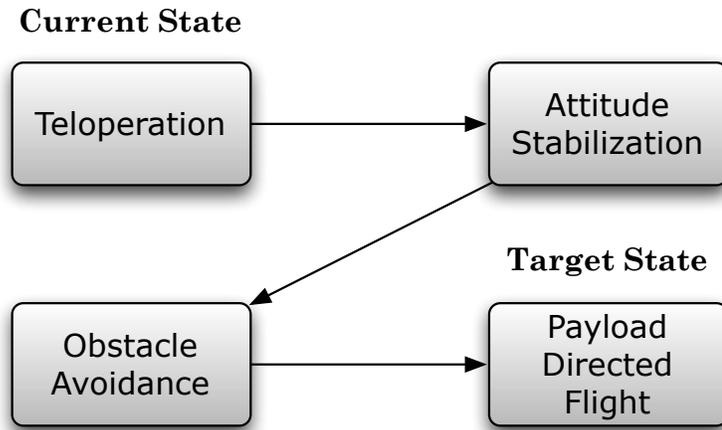
The upper left corner of Figure 23 shows that the operations conducted following Hurricane Katrina were entirely teleoperated. The next step from direct teleoperation (pilot commands as actuator inputs), is attitude stabilization or a fly-by-wire design (pilot inputs as requested 6-DOF attitude modifications). In the time since Katrina, some platforms have reached this attitude stabilization capability, with most current platforms operating somewhere along the continuum between these states. The next step past stabilization is obstacle avoidance and a guarded motion behavior, wherein the pilot requested attitude adjustments are now filtered with an obstacle avoidance behavior to prevent collisions. The

Figure 23: Development path for the implementation of autonomy in VTOL MAVs for urban inspection applications.

final target state for autonomy development in VTOL MAVs should be payload directed flight. Field operators of such a platform, such as USAR operators, are only interested in the payload data output, not how the vehicle stays in the air. Thus, if the pilot or operator can simply direct the payload camera towards their intended target, and the helicopter uses its stabilized hover and obstacle avoidance behaviors to follow the payload as the operator flies the camera, operation and required training for such a platform would both be greatly simplified.
